SITE ASSESSMENT REPORT
FOR
THE DAYTON ELECTROPLATE, INC., SITE
DAYTON, MONTGOMERY COUNTY, OHIO
TDD: S05-9609-018
PAN: 6P1801SI
DOCUMENT CONTROL NUMBER: START-05-23-05019

December 19, 1996

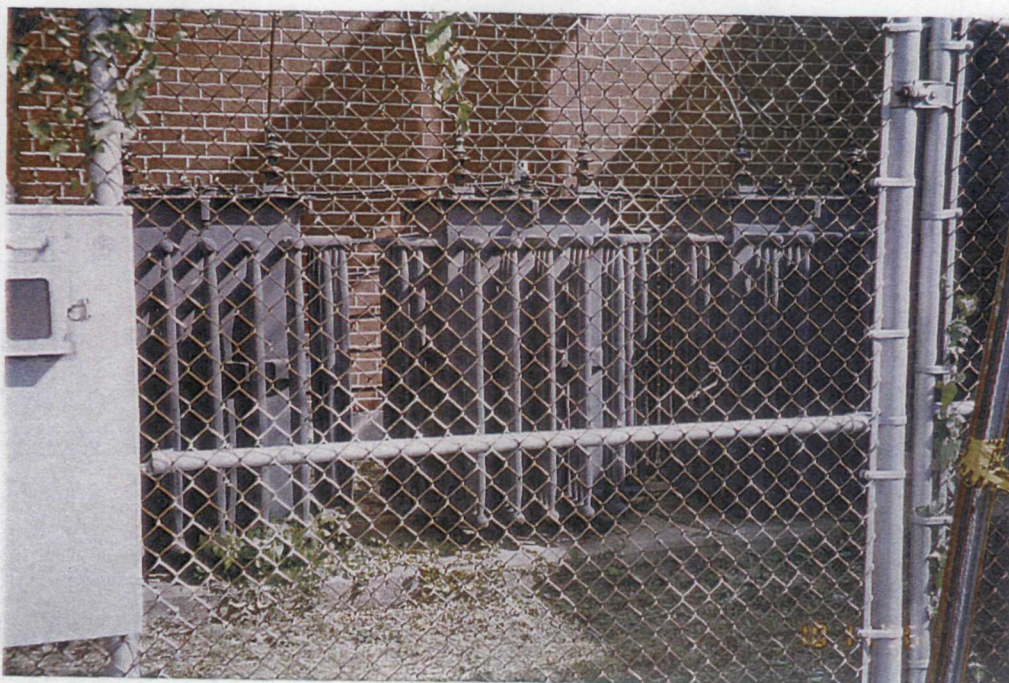
A small area adjacent to Buildings 1 and 3 is enclosed by a separate chain-link fence. Three transformers were observed on a concrete pad in this fenced area. A fourth, smaller transformer was observed on an electrical pole, also within the fenced area. It is not known whether oils in any of the four transformers contain polychlorinated biphenyls.

SITE: Dayton Electro.TDD: S05-9609-018 PAN: 6P1801SA PHOTO: 7
 DIRECTION: East DATE: 10/11/96 PHOTOGRAPHER: Renninger
 DESCRIPTION: Transformers located in fenced area adjacent to
 Buildings 1 and 3.

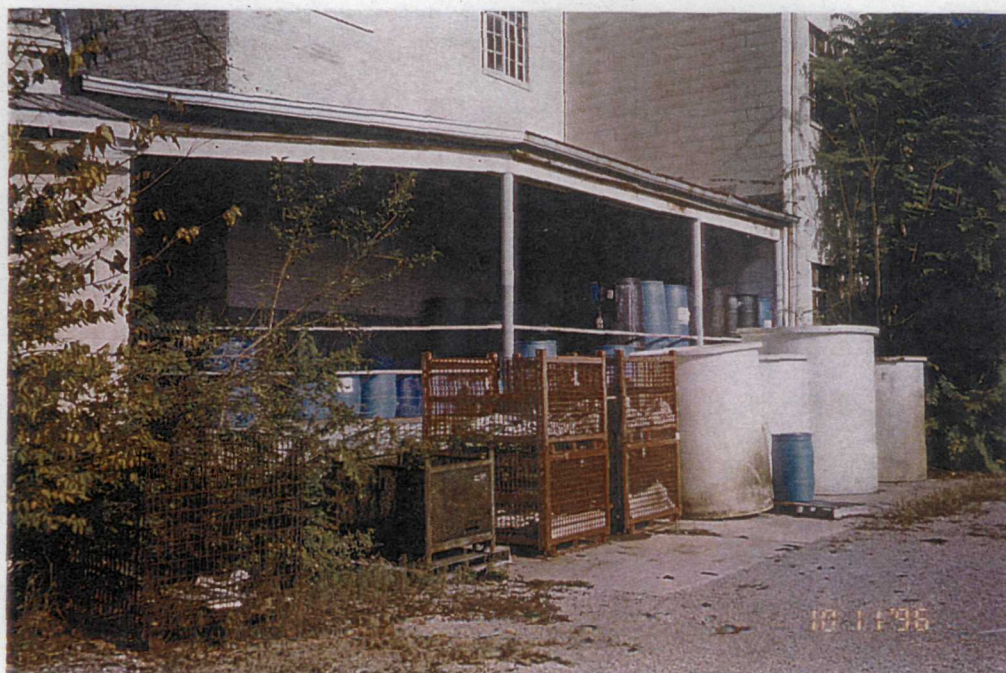
Empty and partially empty drums were observed stored outside, at the south side of Building 1. Acid fumes were observed releasing from the bung opening of one of the drums, which was labelled as containing hydrochloric acid. The drum contained several inches of liquid residues. Air monitoring with the Draeger pump and colorimetric monitoring tubes for hydrochloric acid indicated the release of approximately 8 parts per million (ppm) of hydrochloric acid vapors.

SITE: Dayton Electro.TDD: S05-9609-018 PAN: 6P1801SA PHOTO: 8
 DIRECTION: Northeast DATE: 10/11/96 PHOTOGRAPHER: Renninger
 DESCRIPTION: Empty drum storage area located outside at the south
 end of Building 1.

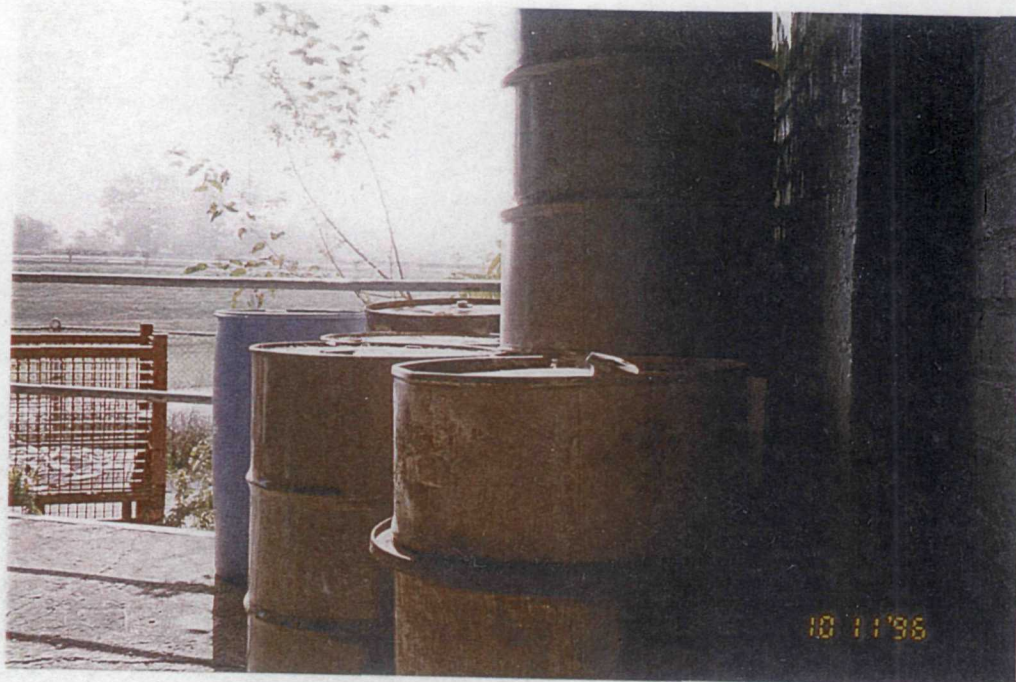
SITE: Dayton Electro.TDD: S05-9609-018 PAN: 6P1801SA PHOTO: 9
 DIRECTION: South DATE: 10/11/96 PHOTOGRAPHER: Renninger
 DESCRIPTION: Close-up of several empty drums stored outside at the facility.

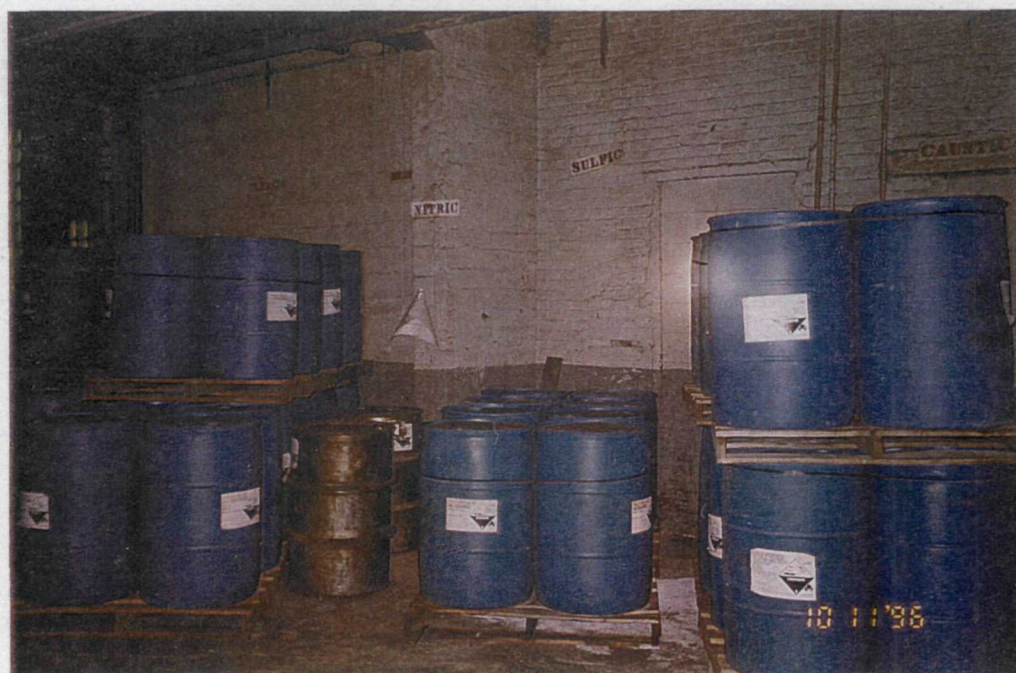
Approximately 70 full 55-gallon drums were observed in Building 1 along the west wall of the main room. Drums of unused products, stacked two drums high, were stored on pallets along the wall. The drums were staged by chemical name, based on small signs located on the wall. However, drums of acids, such as nitric (2 drums), sulfuric (8 drums), and hydrochloric (20 drums), were observed stored adjacent to drums of basic materials, such as sodium hydroxide (16 drums) and sodium hypochlorite (12 drums). A list of drums and containers inventoried by START during the site assessment, separated by building and area, is included as Appendix B.

SITE: Dayton Electro.TDD: S05-9609-018 PAN: 6P1801SA PHOTO: 10
 DIRECTION: West DATE: 10/11/96 PHOTOGRAPHER: Renninger
 DESCRIPTION: Drums of raw materials stored in Building 1. Storage area labelled with chemical names; acids and bases stored adjacent to each other.

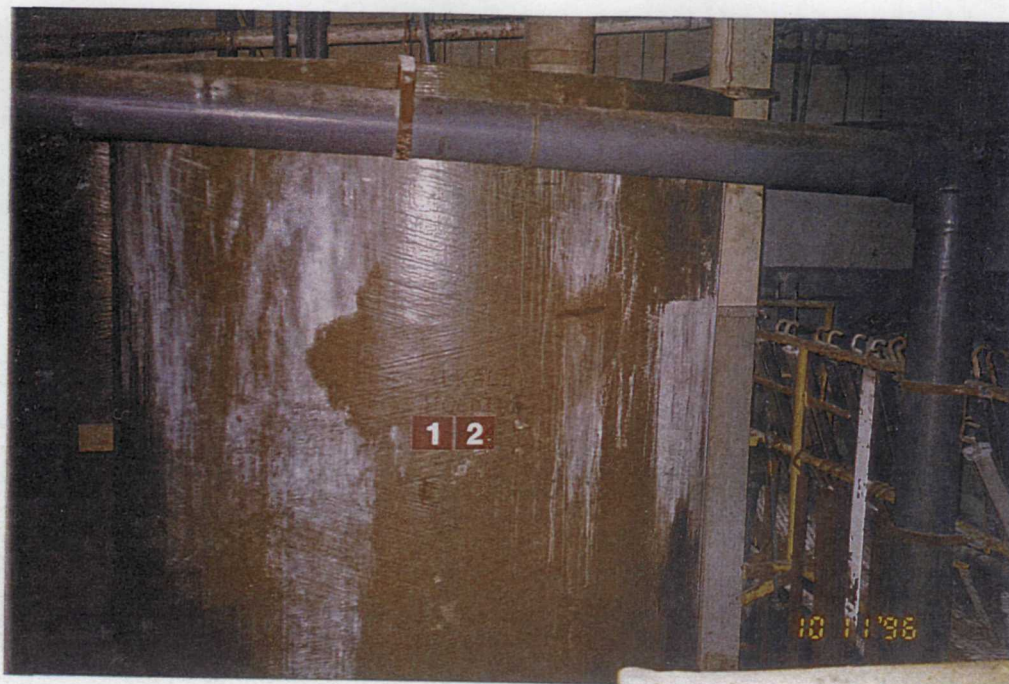
Five large closed, fiberglass-wrapped tanks were observed in the northwest corner of the main room in Building 1. Contents of the storage tanks are unknown, although the tanks are assumed to be full. Access to the tops of each of the storage tanks requires a ladder, which was unavailable at the time of the site assessment. Each tank has an estimated capacity of 3,500 gallons. One of the tanks was labelled as "Alkali Holding." Standing liquids, possibly rain water or leakage from plating vats or the storage tanks themselves, was observed around the base of these storage tanks and around the north end of Plating Line 1. A reading of approximately 280 ppm above background levels was obtained on the PID during the site reconnaissance of this area. An additional 550-gallon capacity closed,

SITE: Dayton Electro.TDD: S05-9609-018 PAN: 6P1801SA PHOTO: 11
 DIRECTION: North DATE: 10/11/96 PHOTOGRAPHER: Renninger
 DESCRIPTION: One of several large storage tanks located in Building 1. Tank labelled "Alkali Holding."

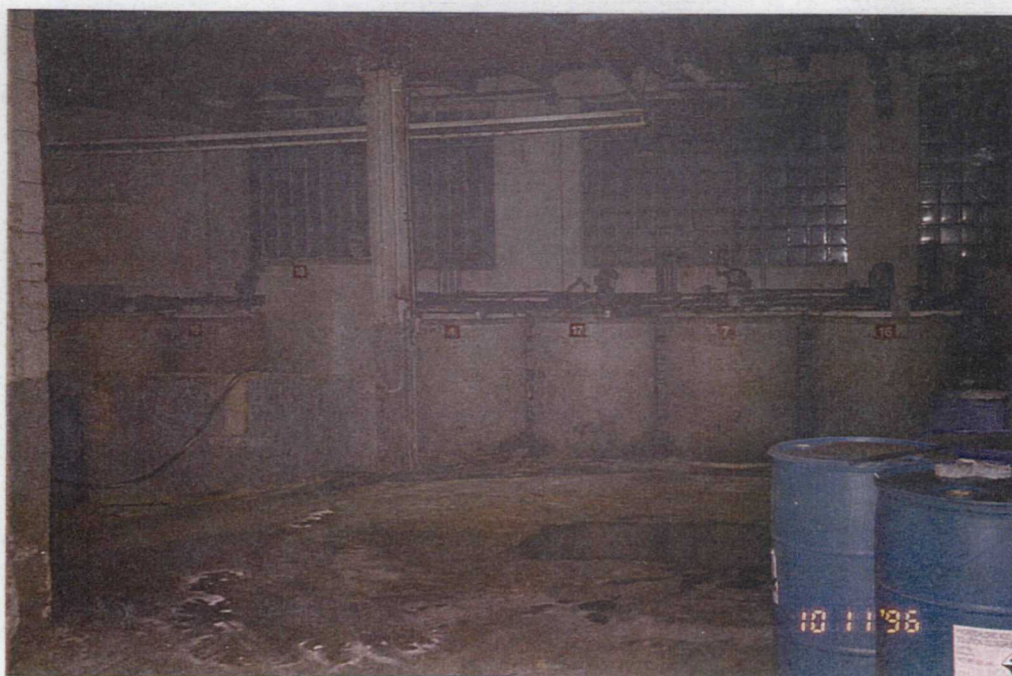
A separate room, located at the south end of Building 1, appeared to have been utilized as a water treatment area for wastewater pretreatment prior to sewer discharge. This room contained an additional five large, open-top, fiberglass-wrapped storage tanks. Each of these tanks had an estimated capacity of 3,000 gallons, and were observed to be approximately 80% full. In addition, a 20-cubic-yard roll-off box, which appeared to be full of dried electroplating sludges, was observed in the southwest corner of the water treatment area. A large vat was also located in the southeast corner of this room. The 2,150-gallon capacity vat was nearly full of an unknown liquid.

SITE: Dayton Electro.TDD: S05-9609-018 PAN: 6P1801SA PHOTO: 16
 DIRECTION: South DATE: 10/11/96 PHOTOGRAPHER: Renninger
 DESCRIPTION: Water treatment tanks located at the south end of Building 1.

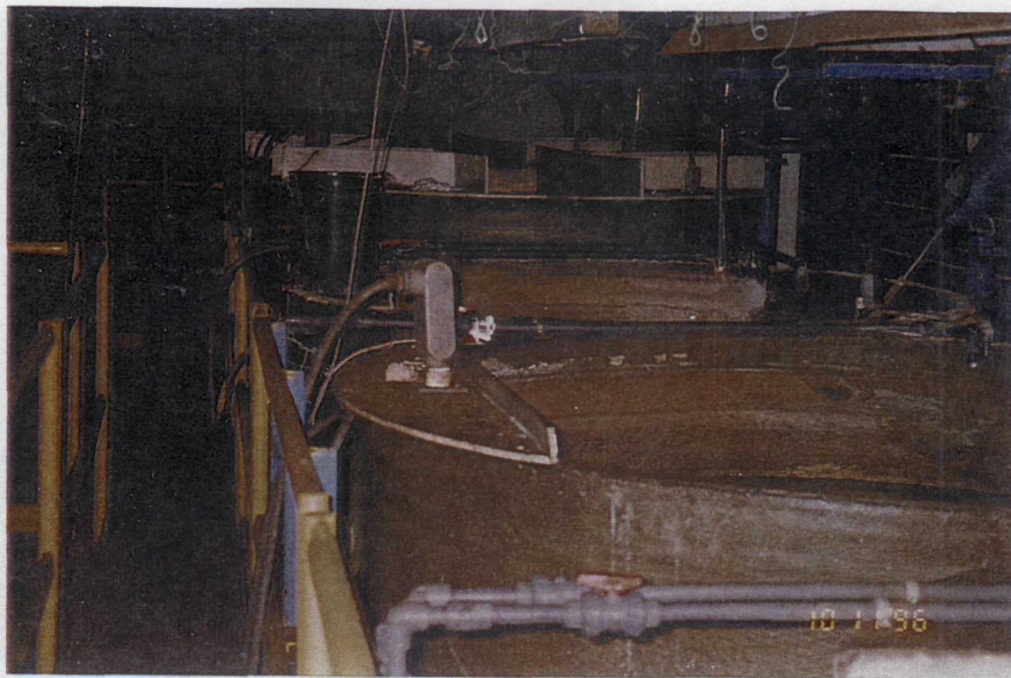
SITE: Dayton Electro.TDD: S05-9609-018 PAN: 6P1801SA PHOTO: 17
 DIRECTION: Southeast DATE: 10/11/96 PHOTOGRAPHER: Renninger
 DESCRIPTION: Close-up view of several of the water treatment tanks located at the south end of Building 1.

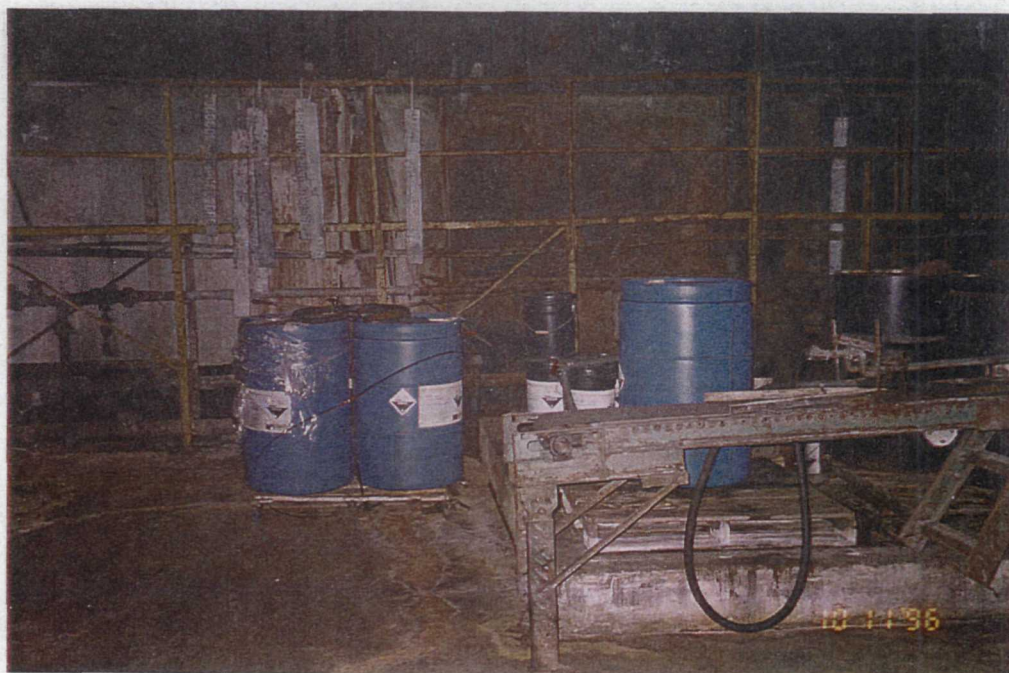
An additional ten full 55-gallon drums of sulfuric acid (4), sodium hydroxide (4), and sodium hypochlorite (2) were observed at the southeast corner of the main room, adjacent to the water treatment area. The concrete floor in the vicinity of these drums was observed to be stained yellow in several locations. Labels from other containers observed in Building 1 indicated the presence of the following products: "Zincrolyte," "Enthobrite," and "SoakClean," as well as several unknown materials.

SITE: Dayton Electro.TDD: S05-9609-018 PAN: 6P1801SA PHOTO: 18
 DIRECTION: East DATE: 10/11/96 PHOTOGRAPHER: Renninger
 DESCRIPTION: Drums and containers found near the water treatment area at the south end of Building 1.

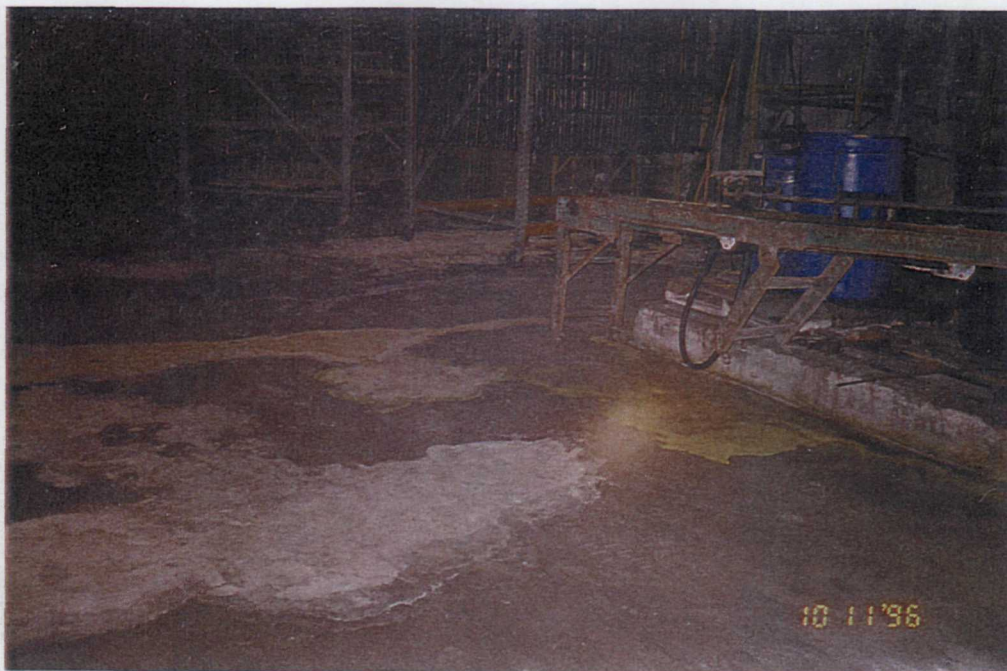
SITE: Dayton Electro.TDD: S05-9609-018 PAN: 6P1801SA PHOTO: 19
DIRECTION: West DATE: 10/11/96 PHOTOGRAPHER: Renninger
DESCRIPTION: Yellow staining observed on the floor in Building 1.

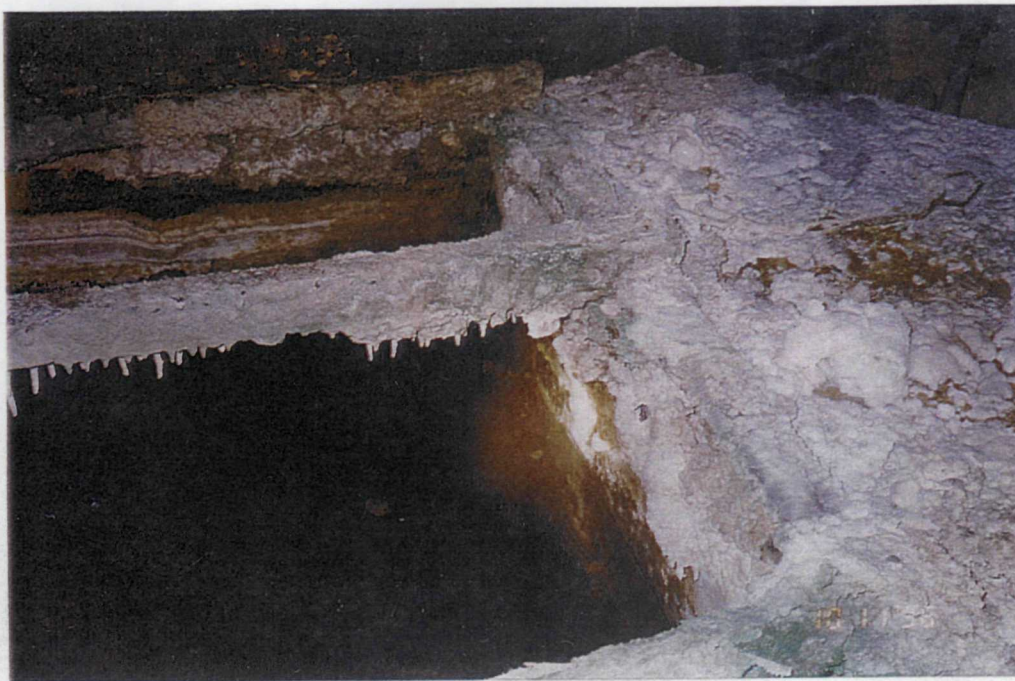
SITE: Dayton Electro.TDD: S05-9609-018 PAN: 6P1801SA PHOTO: 23
 DIRECTION: East DATE: 10/11/96 PHOTOGRAPHER: Renninger
 DESCRIPTION: Close-up view of one of the vats in Building 3 and its contents.

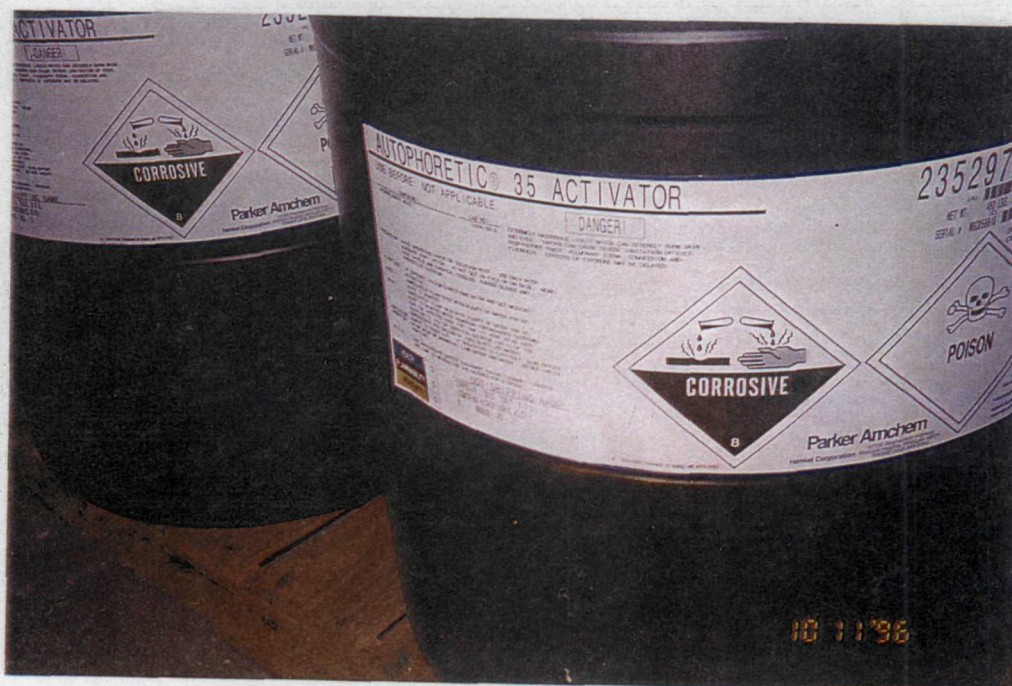
SITE: Dayton Electro.TDD: S05-9609-018 PAN: 6P1801SA PHOTO: 26
 DIRECTION: West DATE: 10/11/96 PHOTOGRAPHER: Renninger
 DESCRIPTION: Close-up view of label from drum containing
 hydrofluoric acid. Drum located along the west wall of Building 2.

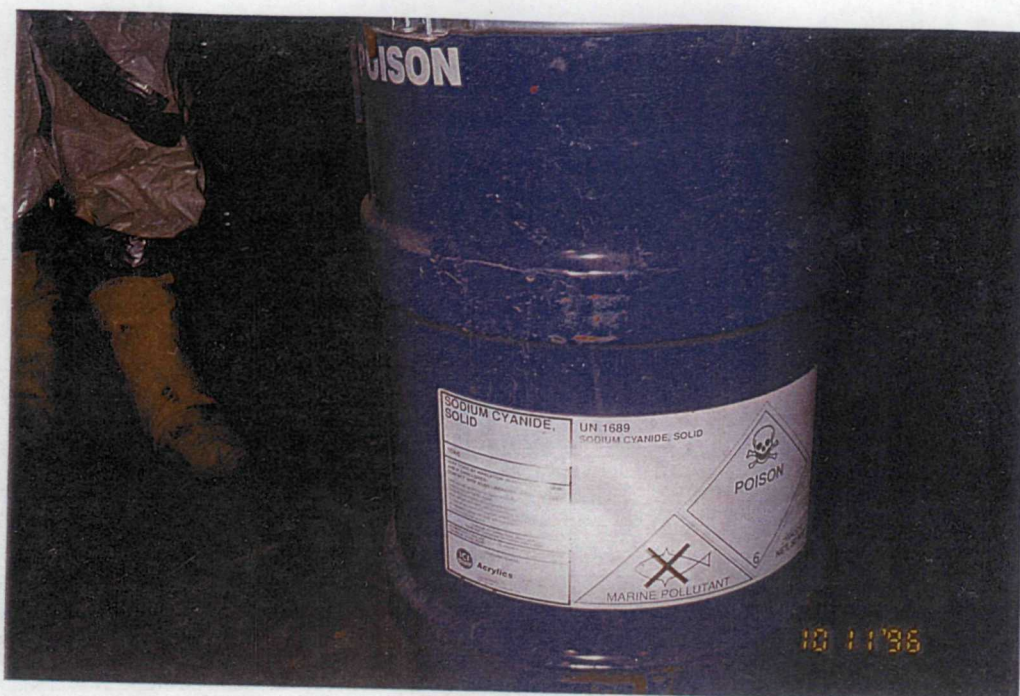
A generator room is located along the west wall of Building 2, between the two storage tanks. One 30-gallon and two 20-gallon drums of sodium cyanide and one 30-gallon and two 20-gallon drums of zinc cyanide were observed in this room.

SITE: Dayton Electro.TDD: S05-9609-018 PAN: 6P1801SA PHOTO: 27
 DIRECTION: West DATE: 10/11/96 PHOTOGRAPHER: Renninger
 DESCRIPTION: Close-up view of label from drum containing sodium cyanide. Drum located along the west wall of Building 2.

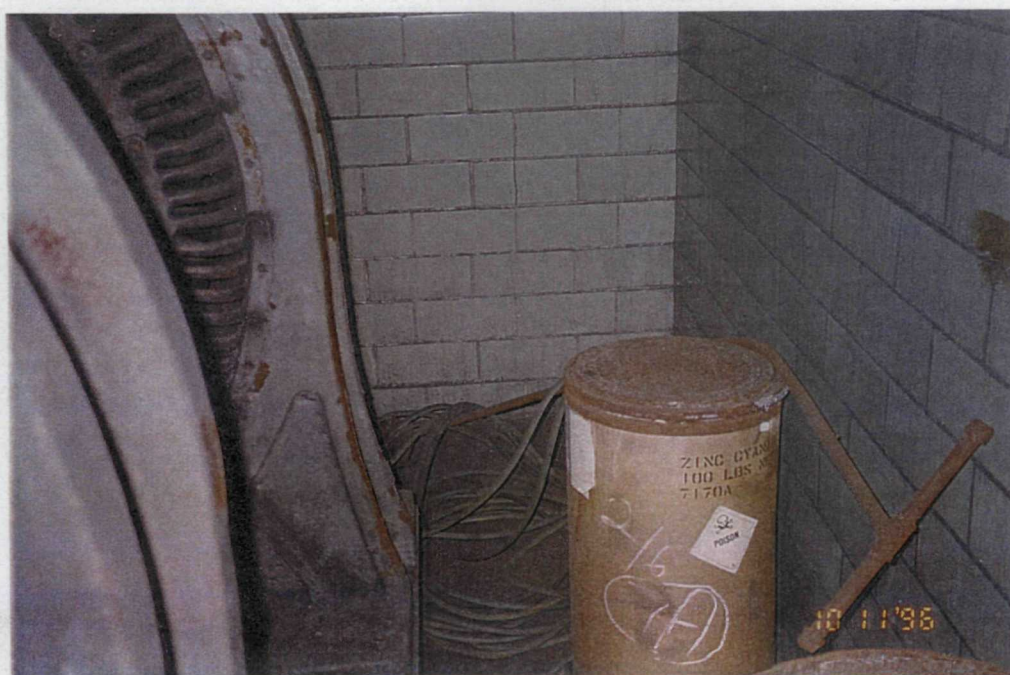
SITE: Dayton Electro.TDD: S05-9609-018 PAN: 6P1801SA PHOTO: 28
 DIRECTION: West DATE: 10/11/96 PHOTOGRAPHER: Renninger
 DESCRIPTION: Close-up view of label from drum containing zinc cyanide. Drum located in Building 2.

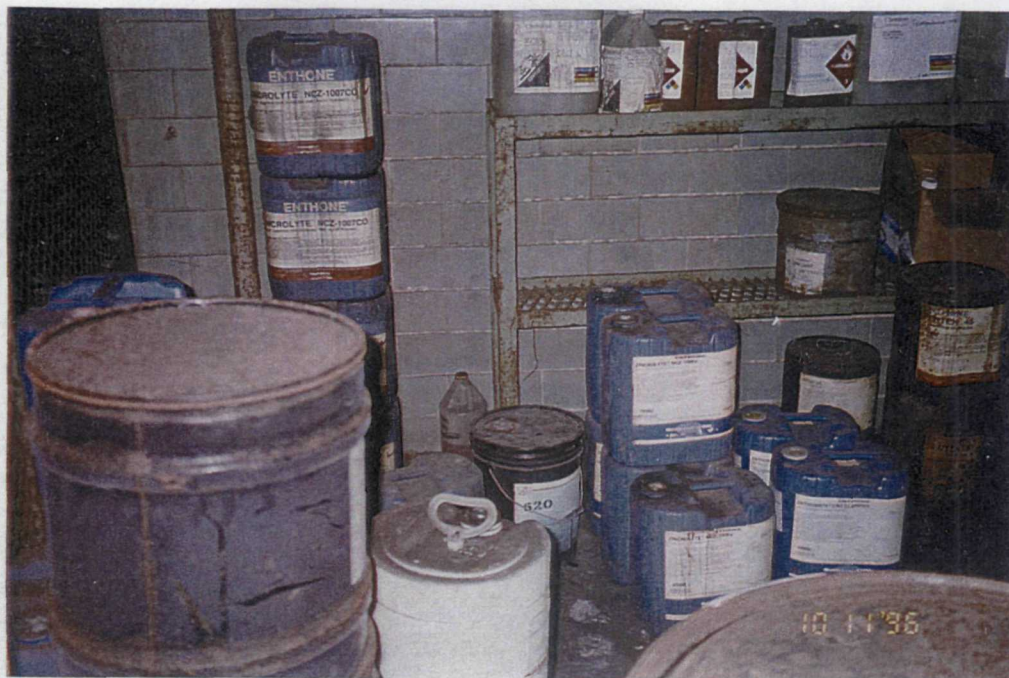
SITE: Dayton Electro.TDD: S05-9609-018 PAN: 6P1801SA PHOTO: 29
 DIRECTION: Southwest DATE: 10/11/96 PHOTOGRAPHER: Renninger
 DESCRIPTION: Small containers of various chemicals found in a storage area in Building 2.

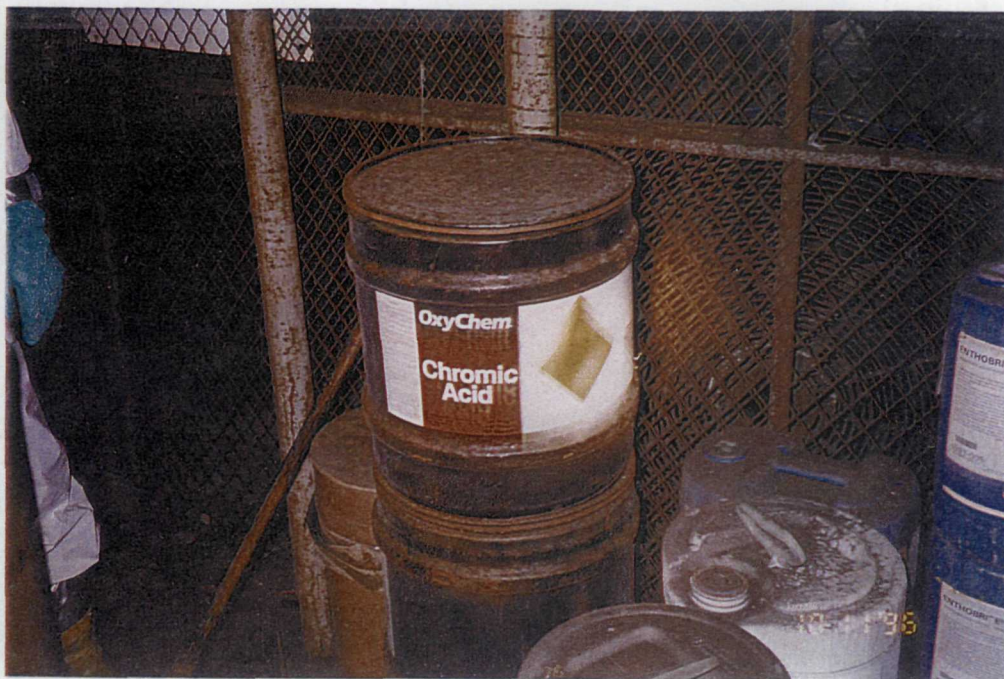
SITE: Dayton Electro.TDD: S05-9609-018 PAN: 6P1801SA PHOTO: 31
DIRECTION: East DATE: 10/11/96 PHOTOGRAPHER: Renninger
DESCRIPTION: Close-up view of label from small container of chromic
acid found in a storage area in Building 2.
